Job Name: Gloucester Live Fire Training Structure ("Burn Building") Structural Evaluation

Gloucester Burn Building Survey  
February 12, 2009

**Gloucester Live Fire Training Structure ("Burn Building")**

Gloucester Burn Building Survey  
March 11, 2011

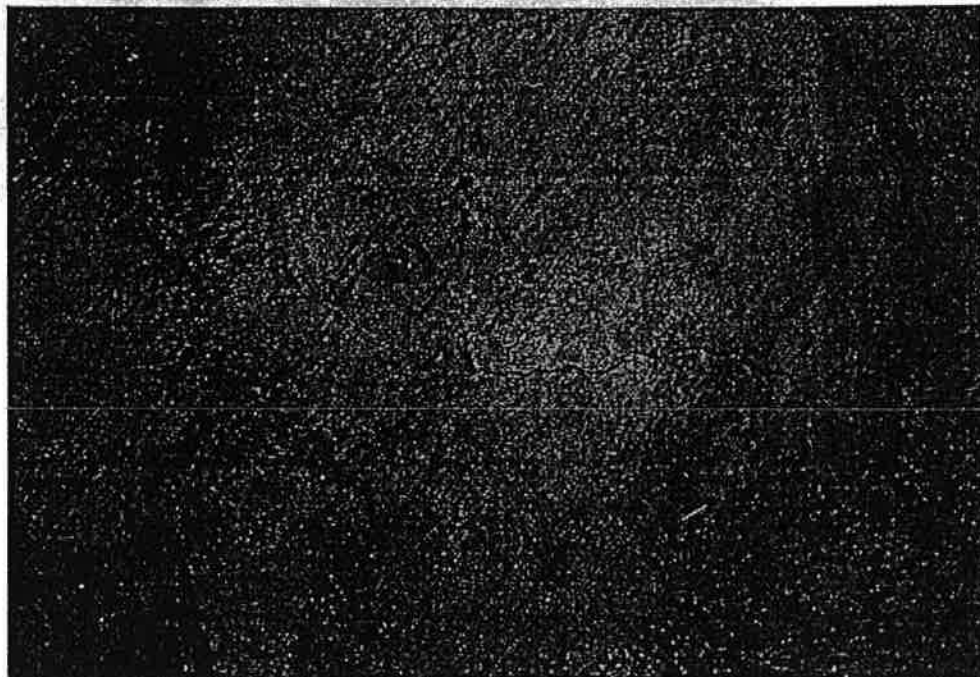
Item	Observations and Recommended Actions
Concrete slab-on-grade	<p><u>Observations:</u> Minor <i>cracks</i>, most likely due to concrete shrinkage during the initial curing exist in the top surface of the slab-on-grade.</p> <p><u>Recommended Actions:</u> No repair required since the concrete is not structural. Observe cracks periodically to determine if their condition is worsening. Should any crack grow to exceed 1/16" in width, then repairs will be required.</p>

Minor crack in slab-on-grade

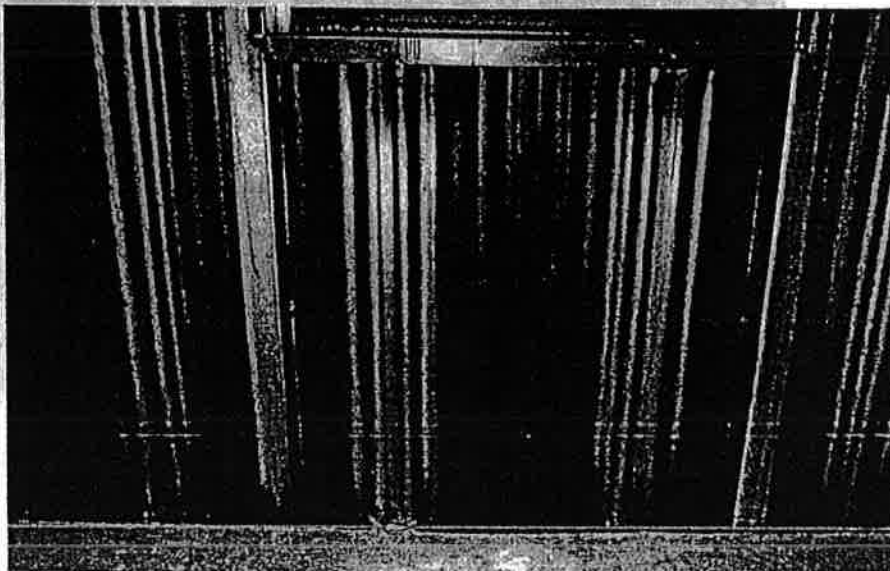
Minor corrosion and heat exposure on second floor walls

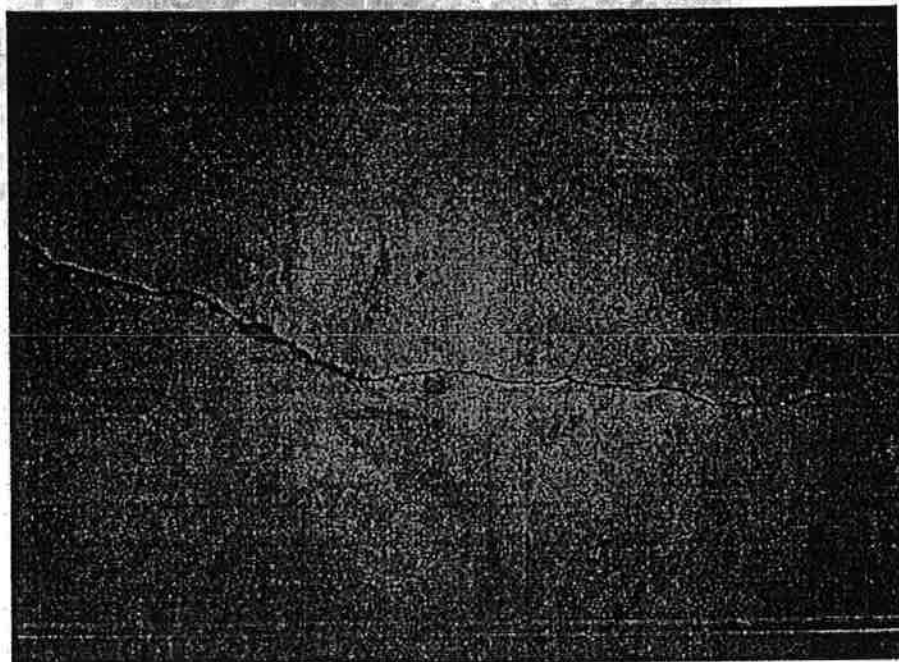
Item	Observations and Recommended Actions
Concrete topping at floors and roof	<p><u>Observations:</u> Minor to moderate <i>cracks</i>, most likely due to concrete shrinkage during the initial curing and thermal expansion and contraction during live fire training, exist in the top surface of the concrete topping at the second floor.</p> <p><u>Recommended Actions:</u> Seal cracks that are wider than 1/16" thick. Options include routing and sealing with a flexible sealant, such as Sikaflex 1a, or epoxy injection with Sikadur 52 or an equivalent product. The remaining cracks that are less than 1/16" thick do not require repairs at this time but should be monitored for further deterioration. The floor of the burn room should be covered with fire brick to help prevent future cracks and <i>spalls</i> and to help prevent the sealant from melting.</p>

**Crack in second floor concrete topping**

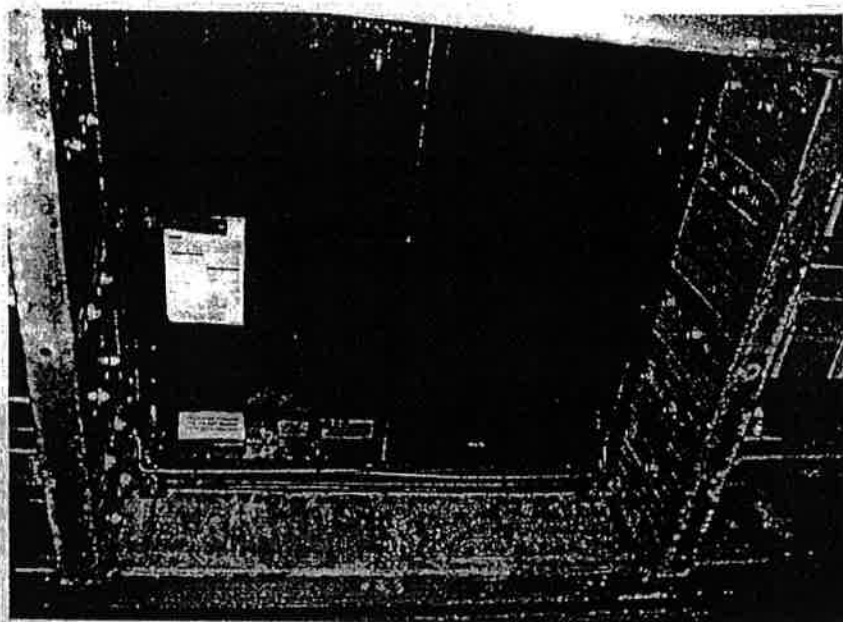
Item	Observations and Recommended Actions
Floor and Roof hatches	<u>Observations:</u> Minor corrosion on floor and roof framing around openings. <u>Recommended Actions:</u> No repair required.

Minor corrosion on second floor hatch

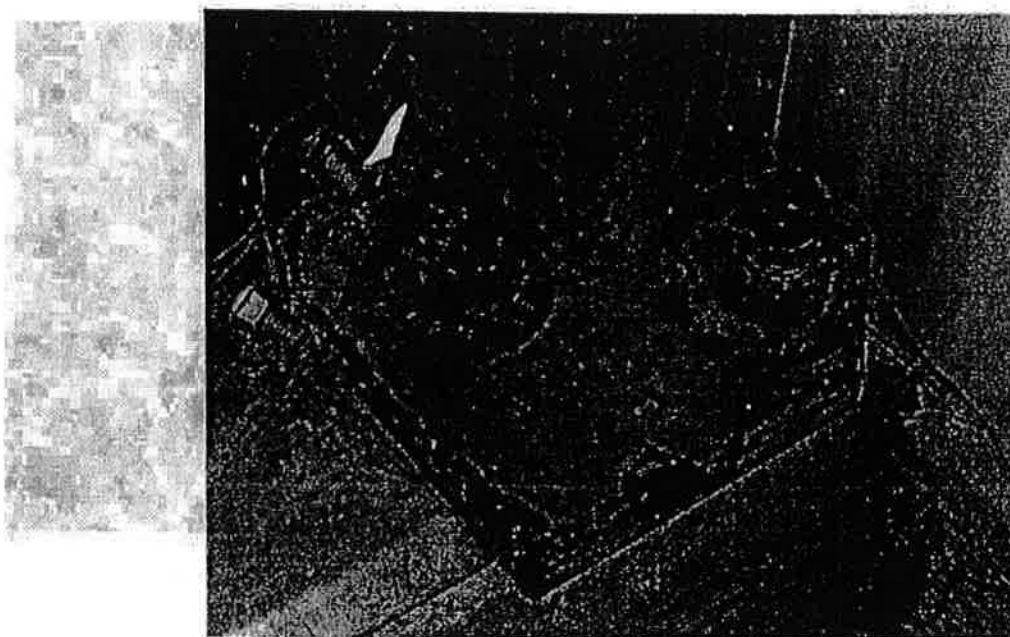
Item	Observations and Recommended Actions
Wall panel base plates and anchor bolts	<p><u>Observations:</u> There is minor corrosion on the base plates and anchor bolts at all wall panel intersections.</p> <p><u>Recommended Actions:</u> Remove corrosion and provide two coats of galvanizing repair paint.</p>

**Minor corrosion on wall panel intersection base plate and bolts**

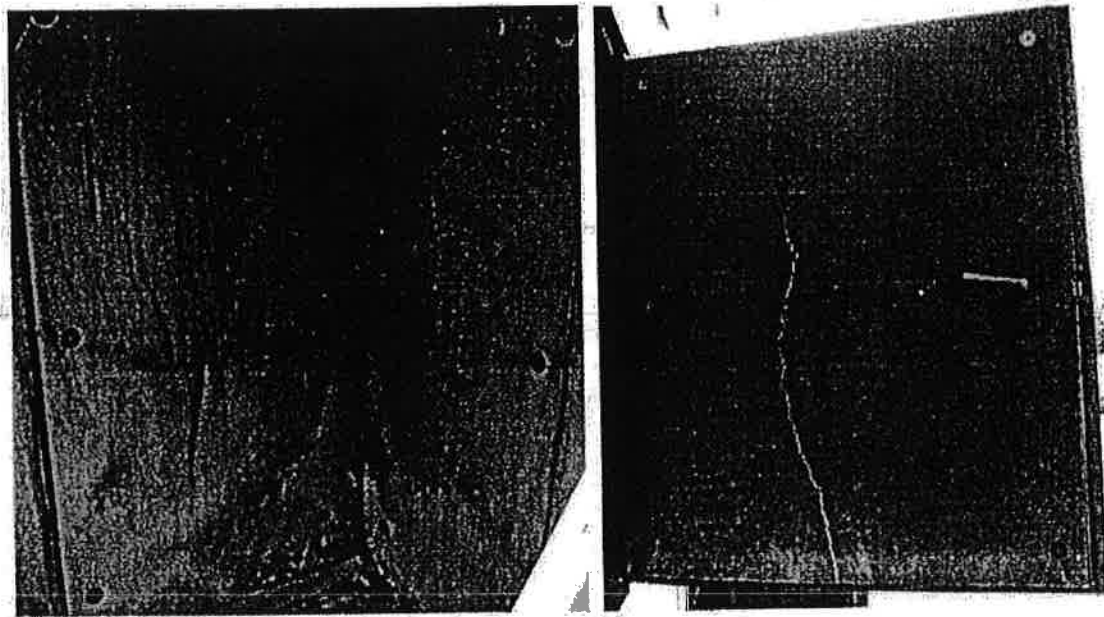
Item	Observations and Recommended Actions
Thermal Lining	<p><u>Observations:</u> There are four cracked Super Padgenite wall panels in the burn corner of the burn room, plus two cracked ceiling panels and one cracked panel on the window shutter. There is one chipped panel at the exterior door jamb of the burn room.</p> <p><u>Recommended Actions:</u> Replace panels when the cracks pass through the entire board thickness.</p>

Cracked wall panels (left) and cracked shutter panel (right)

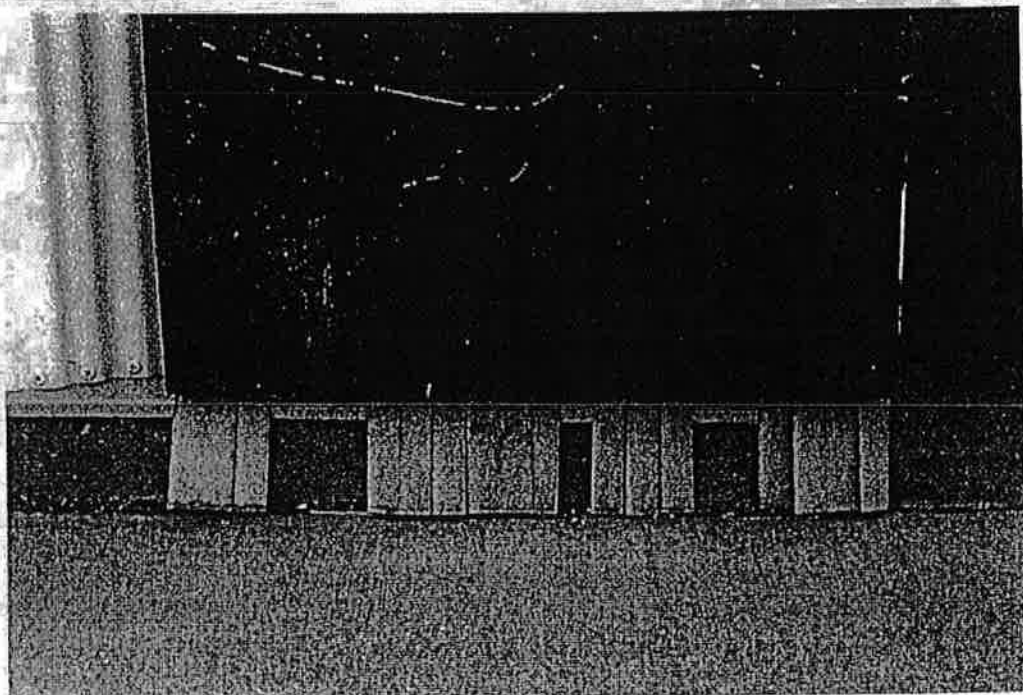
Item	Observations and Recommended Actions
Doors and Windows (Items 1, 2, and 8 in Appendix 1 Field Notes)	<p><u>Observations:</u> Minor corrosion and peeling paint on hollow metal doors, shutters, shutter magnets, and frames. Window shutter magnets do not consistently hold shutters in open position if there is a breeze. At the bottoms of all exterior doors, some of the flaps that keep light out during training are missing.</p> <p><u>Recommended Actions:</u> No repair required. At Owner's option, improve system for holding window shutters open and replace missing flaps at bottoms of doors.</p>

Minor corrosion on door and missing flaps at bottom of door.

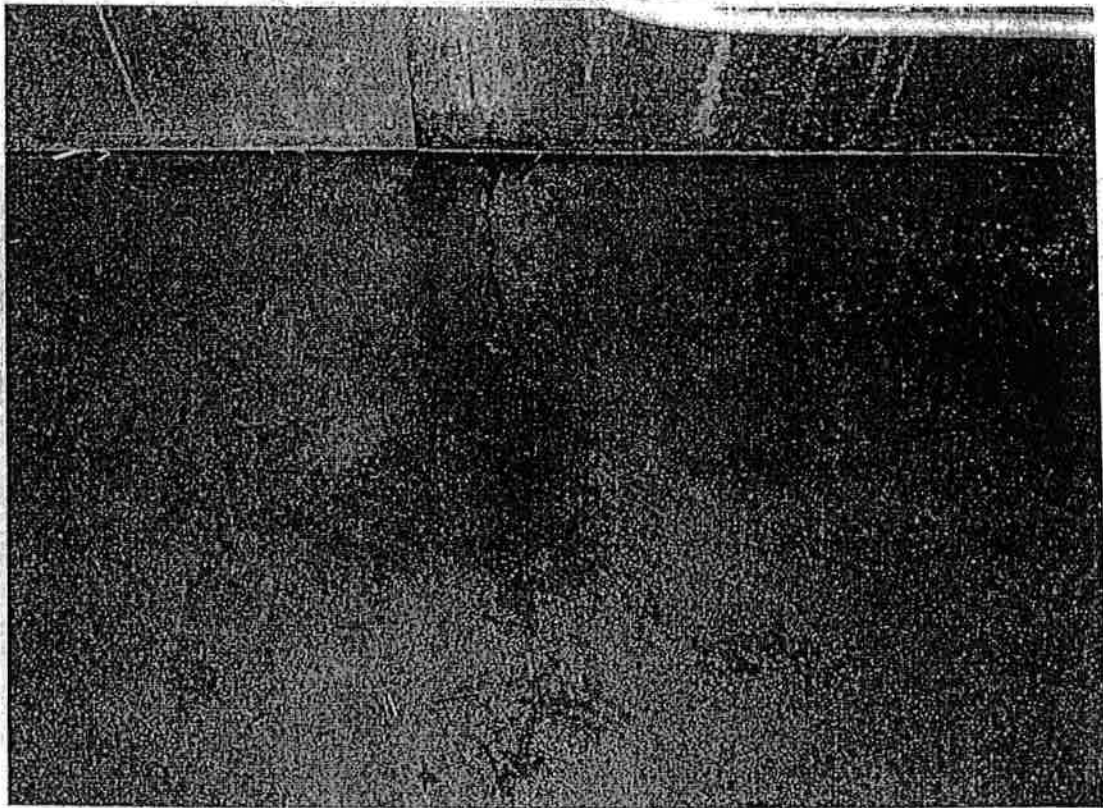
Item	Observations and Recommended Actions
Concrete ground floor slab (Item 3 in Appendix 1 field notes)	<p><u>Observations:</u> Minor <i>cracks</i>, most likely due to concrete shrinkage during the initial curing, in the top surface of the ground floor slab.</p> <p><u>Recommended Actions:</u> No repair required since the concrete is likely non-structural and since the cracks are minor. Observe cracks periodically to determine if their condition is worsening. Should any crack grow to exceed 1/16" in width, then repairs will be required.</p>

Minor crack in ground floor slab

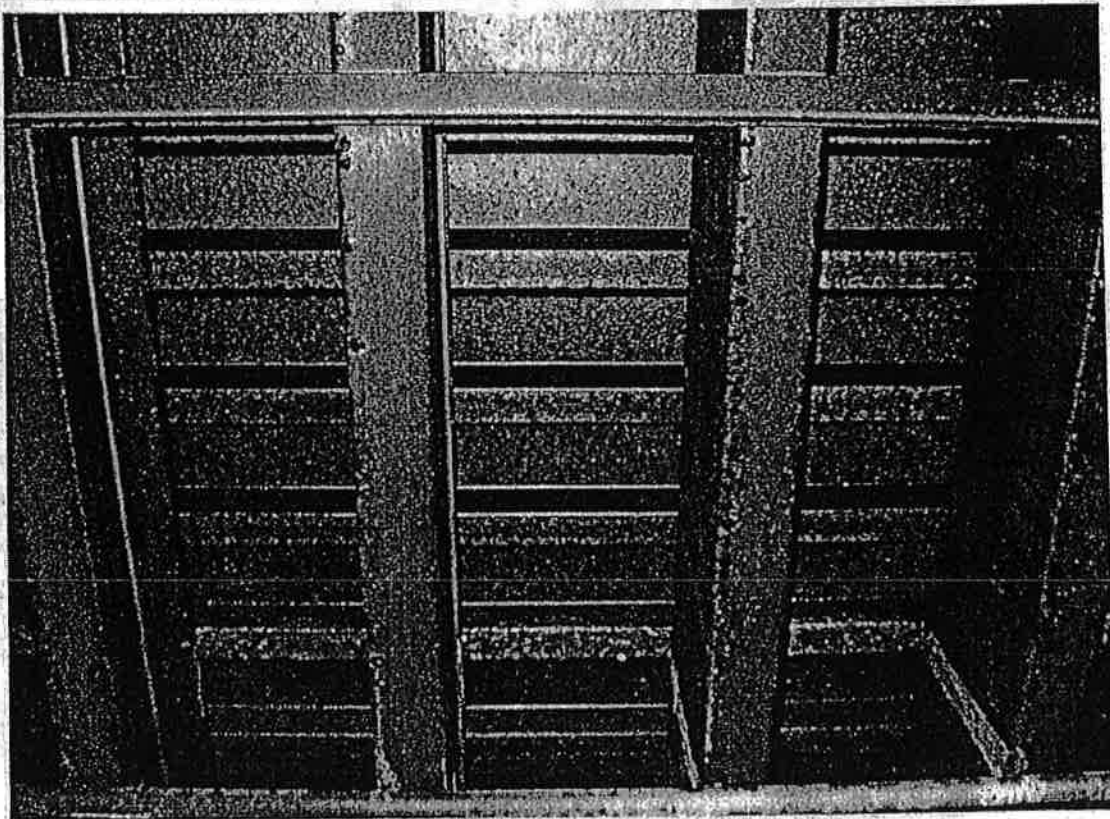
Item	Observations and Recommended Actions
Steel Framing (Items 4, 5, and 13 in Appendix 1 field notes)	<p><u>Observations:</u> There is minor corrosion on the steel framing, including floor and roof deck, C joists, roof trusses, wall studs, corrugated wall panels, and column base plates and anchor bolts throughout the structure.</p> <p><u>Recommended Actions:</u> No repair is required at this time because the corrosion appears to be minor surface rust. Monitor the corrosion, which is currently most severe at the column anchor bolts. If it worsens, corrosion removal and re-coating could be required.</p>

**Minor corrosion on ceiling deck and C joists.**

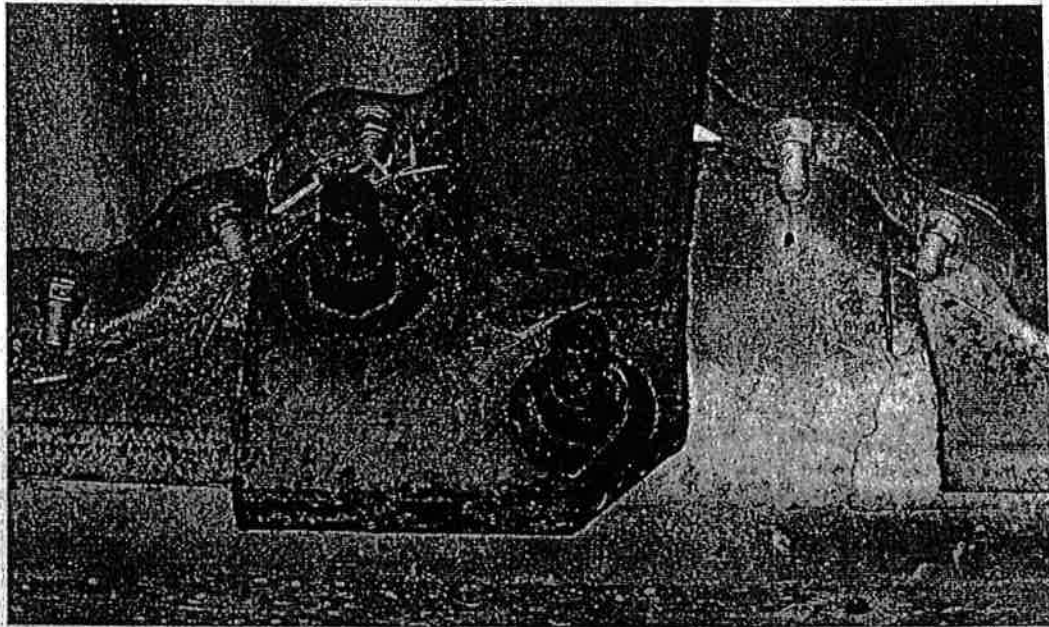
**Minor corrosion column anchor bolts.**

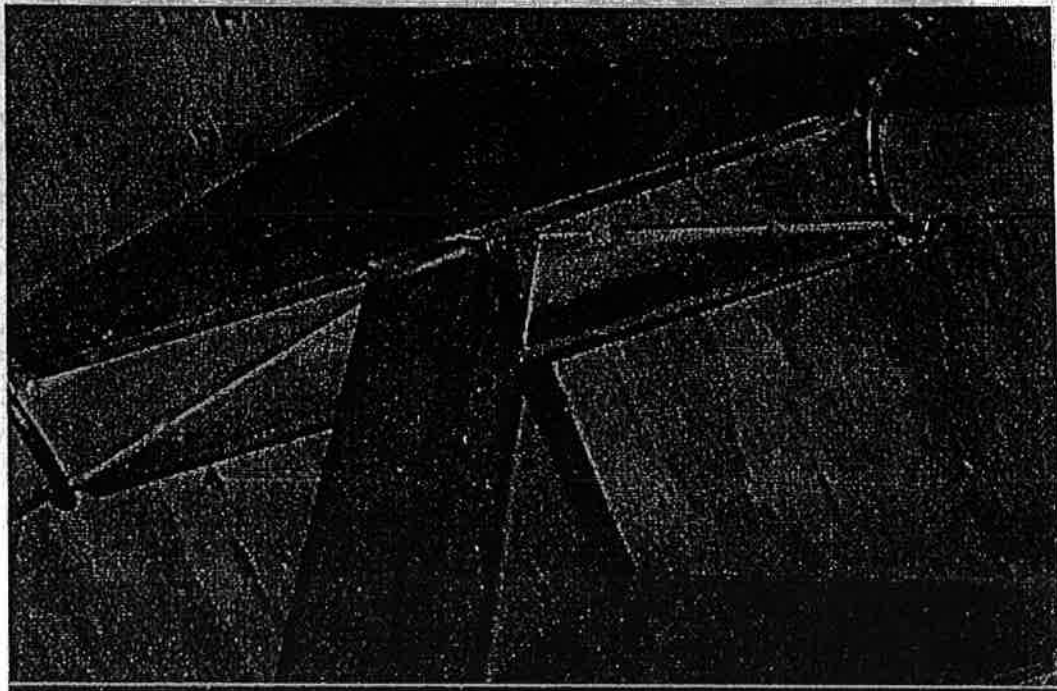
**Minor corrosion on roof trusses.**

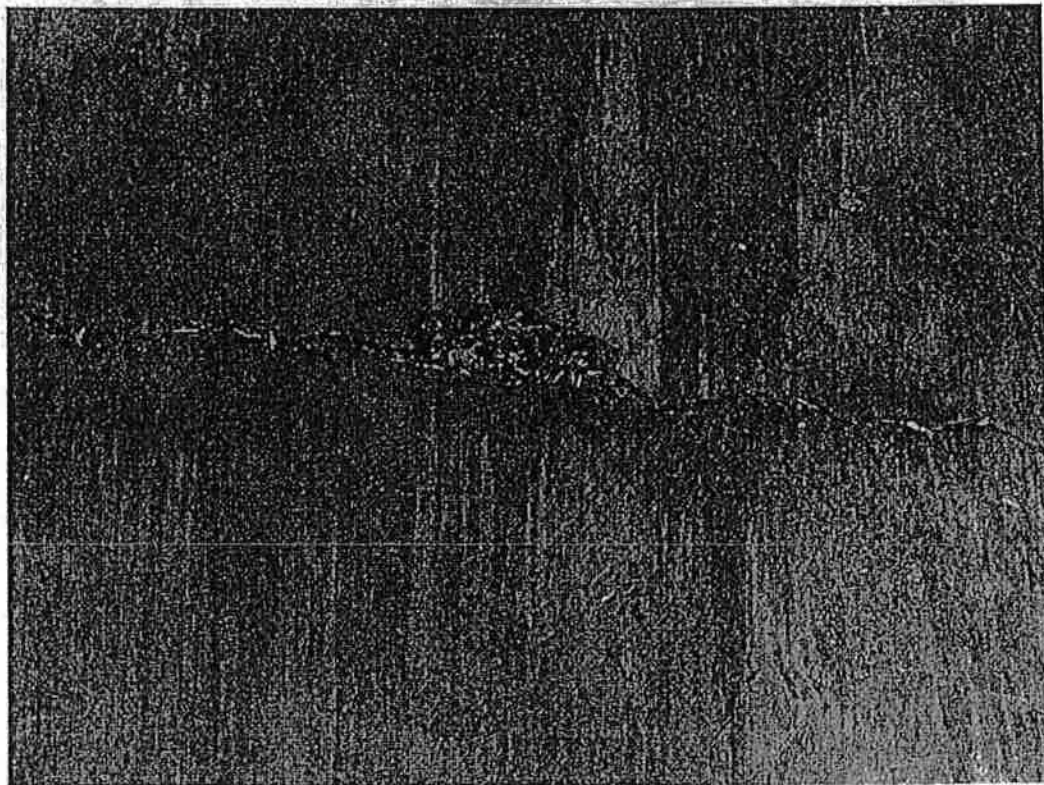
Item	Observations and Recommended Actions
Concrete topping at floors and roof (Items 10 and 11 in Appendix 1 field notes)	<p><u>Observations:</u> Minor to moderate <i>cracks</i>, most likely due to concrete shrinkage during the initial curing and lack of expansion joints during the initial cure, in the top surface of the concrete topping at the second floor. Minor <i>spall</i> at location where intersecting cracks causes concrete to become too loose.</p> <p><u>Recommended Actions:</u> Rout and seal cracks with an exterior quality, flexible sealant, such as Sikaflex 1a. Patch spall with a high-strength, high bond strength, non-shrink grout, such as SikaTop 123 Plus.</p>

**Spall in second floor concrete topping.**

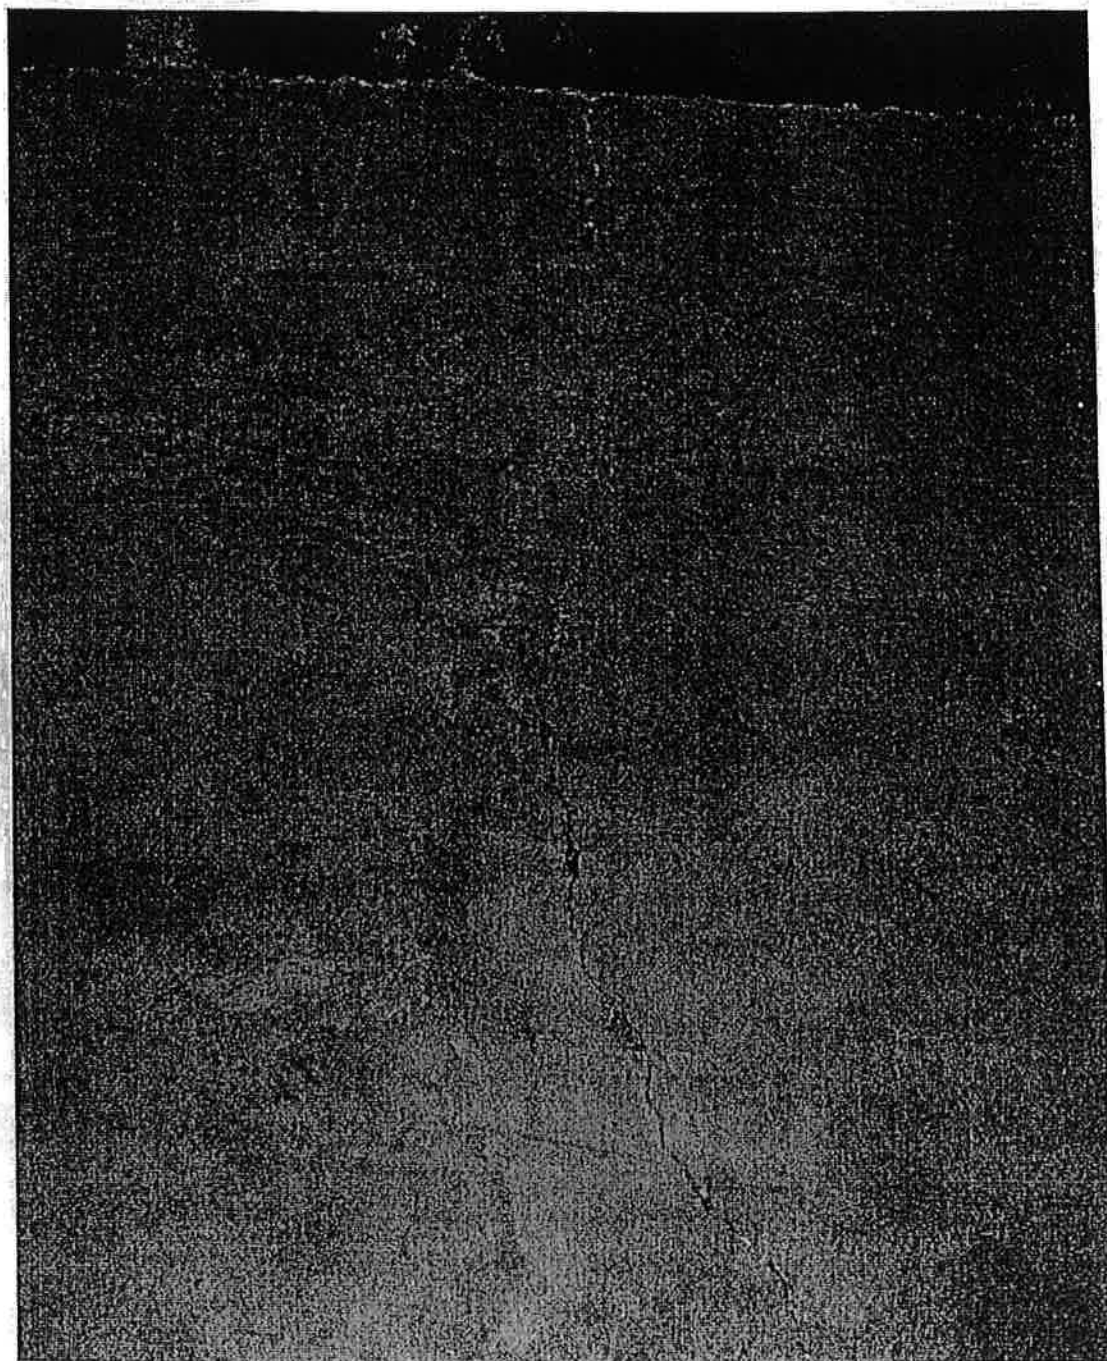
**Crack in second floor concrete topping.**

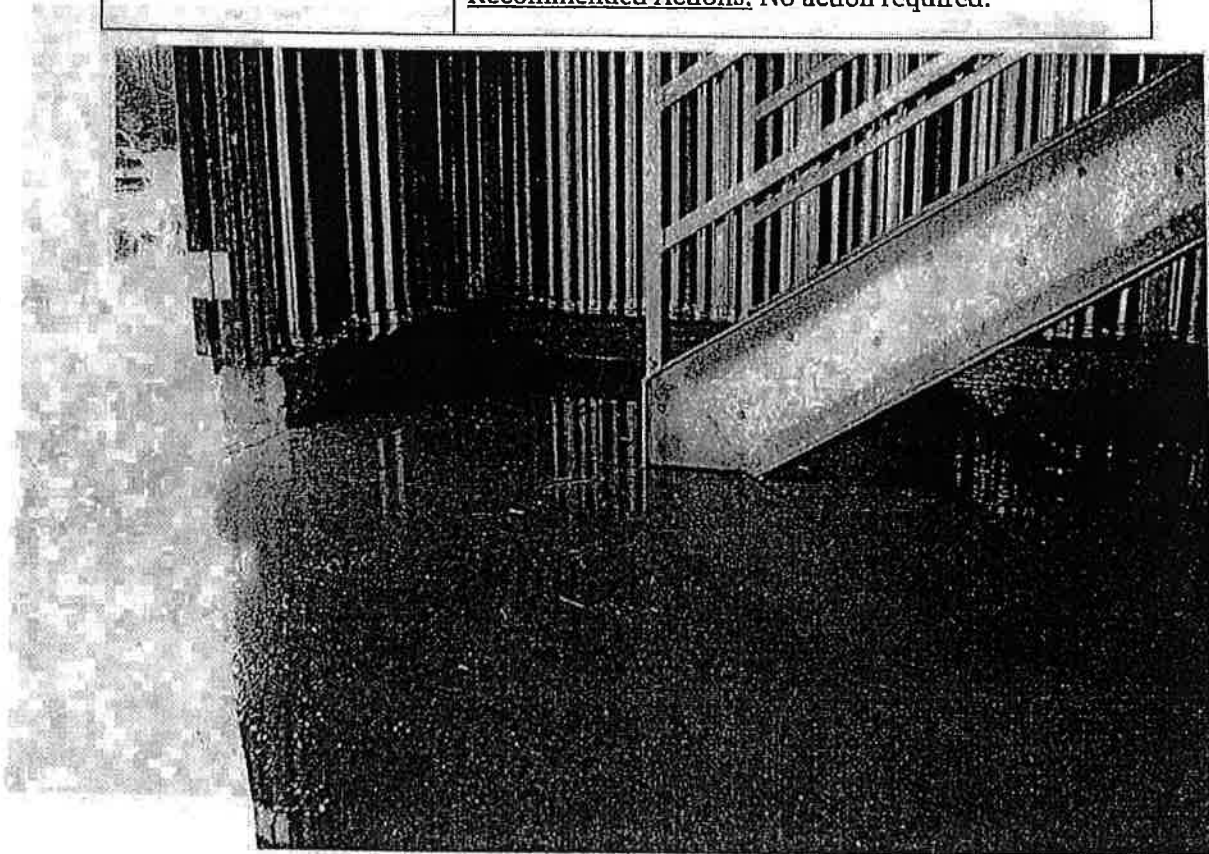
Item	Observations and Recommended Actions
Leaks (Item 9 in Appendix 1 field notes)	<p><u>Observations:</u> The structure leaks in many locations, especially in the stair tower, due to the detailing of the pre-engineered building manufacturer.</p> <p><u>Recommended Actions:</u> No action required.</p>

**Ponding at first floor of stair tower due to leaks throughout structure.**

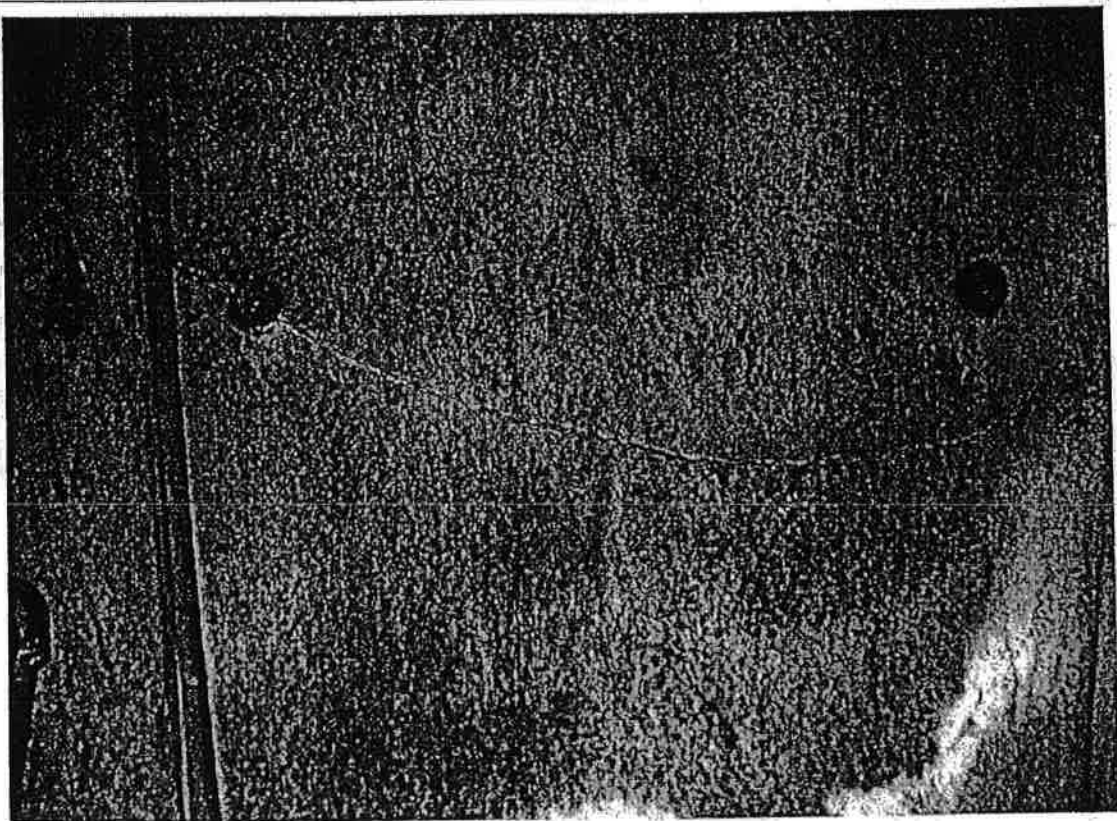
Item	Observations and Recommended Actions
Thermal Lining (Items 6 and 7 in Appendix 1 field notes)	<p><u>Observations:</u> There are two cracked Padgenite wall panels in the burn corner of Room 100, in which the cracks penetrate through the entire panel thickness, plus one cracked panel on the window shutter (which does not appear to penetrate through the entire panel thickness).</p> <p><u>Recommended Actions:</u> Confirm with Kidde that the temperature at the crack locations in the two wall panels (approximately 2' above the floor behind the gas prop) will be less than 300 degrees F. If so, then no action required.</p>

**Cracked wall panel.**
